Industrial Automation Manufacturer

Box Lug

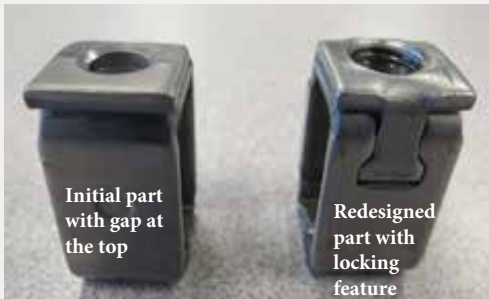
First, Ultra focused on fixing the alignment and thread quality issues which led to a minor redesign of box lug. We introduced a locking feature that minimized the gap and created a more secure fit. This can be seen on the box lug located on the right-hand side of the picture.

Alignment issues on the top of the part were decreasing the quality and performance of the inner threads.

The new locking feature **improved** the alignment of the part which allowed the inner threads to function as designed.
